<b>Prüfbericht - Nr.:</b> <i>Test Report No.:</i>	<b>IND/BLR/CH/2018/1502R</b>	<b>Seite 1 von 4</b> <i>Page 1 of 4</i>	
<b>Auftraggeber:</b> <i>Client:</i>	<b>Sunflex Recycling Pvt Ltd</b> Plot No. – 274/4, Shital Estate B/H Satyamev Complex, Opp. Gujrat High Court, S. G. Highway, Sola Ahmedabad, 380060, India		
<b>Gegenstand der Prüfung:</b> <i>Test item:</i>	Rubber Tiles		
<b>Bezeichnung:</b> <i>Identification:</i>	<b>Serien-Nr.:</b> <i>Serial No./ Document Submitted:</i>		
<b>Wareneingangs-Nr.:</b> <i>Receipt No.:</i>	06032018	<b>Eingangsdatum:</b> <i>Date of receipt:</i>	06.03.2018
<b>Order No.:</b>	1803301976	<b>Testing Period:</b>	15.03.2018 to 17.03.2018
<b>Prüfart:</b> <i>Testing location:</i>	TÜV Rheinland India Pvt Ltd, Plot No. 27/B, 2nd Cross Road, Electronics City , Phase 1, Bangalore - 560 100, Karnataka, India.		
<b>Prüfgrundlage:</b> <i>Test specification:</i>	Customer's Requirement : Resistance breaking Test as per DIN 53504

### TEST RESULTS

**Test Name:** Resistance breaking Test

**Test Method:** DIN 53504

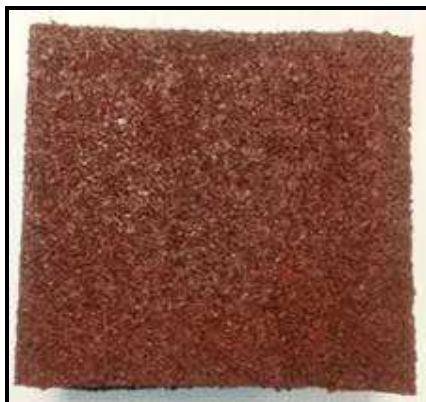
Sample Photograph as in Received Condition

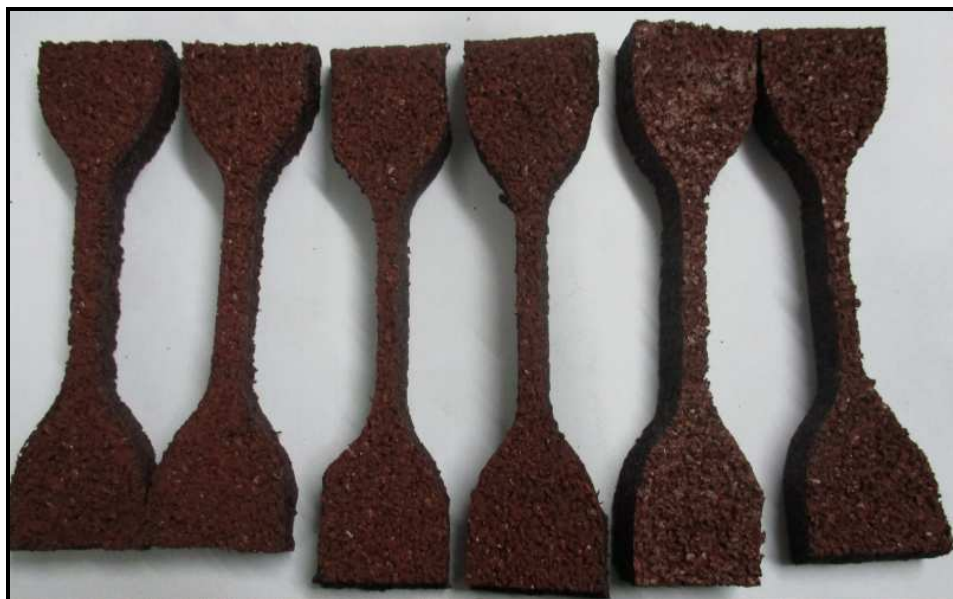
Photograph of Test Specimens

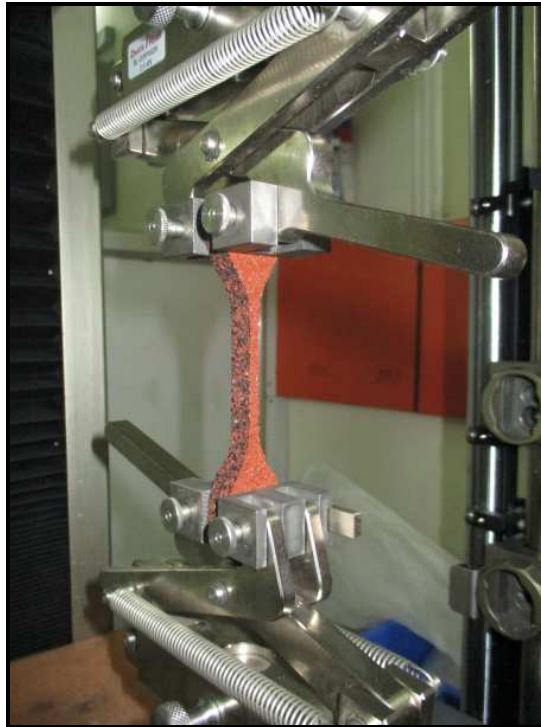
**Test Condition:** Lab Environmental condition -  $23\pm 2^{\circ}\text{C}$ ,  $50\pm 5\%\text{RH}$   
Test Speed – 200 mm/min.  
Pre – Load – 0.1 N

**Photograph of Test Setup**

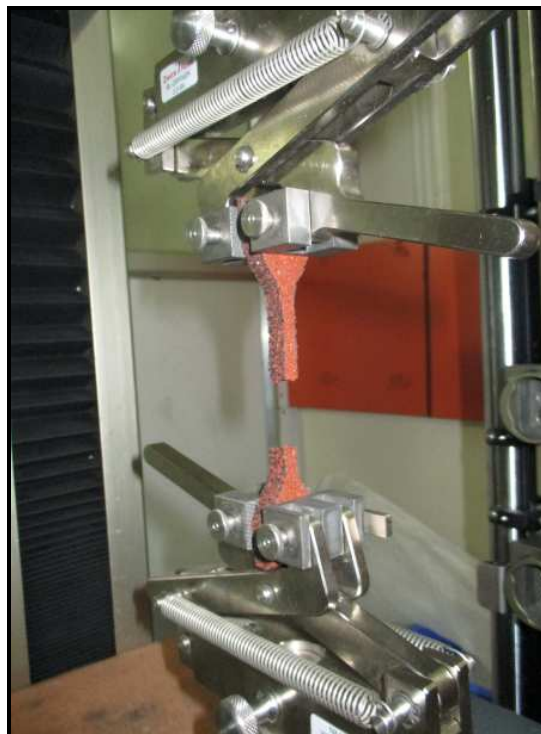
**After test Photograph**
